F.A.M.E., Inc.

## Facility Committee Meeting

**Audubon Charter School**  
**Program and Building Assessments**  
*New Upper Elementary & Middle School Campus*

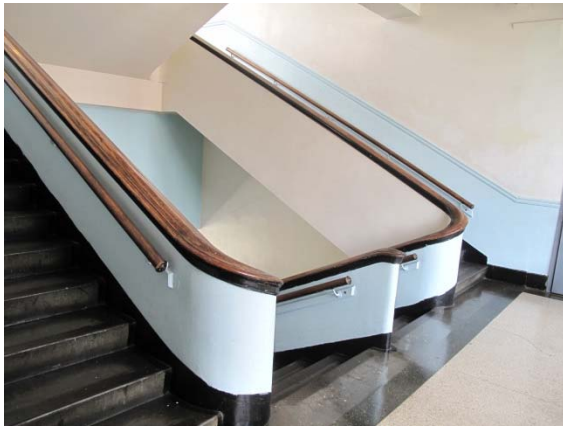
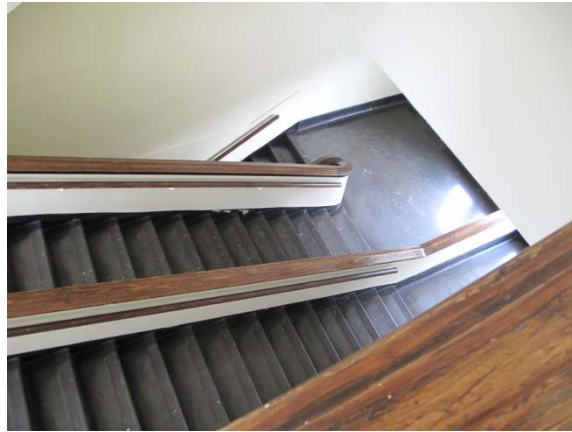
**Stairs:**

Stair guardrails and handrails are consistently not to current code height and also do not extend the proper distance beyond top and bottom treads and risers.

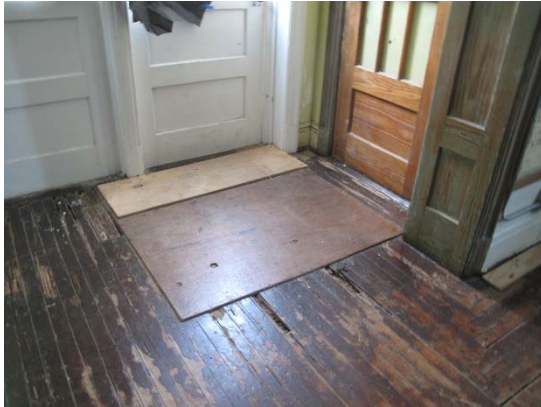
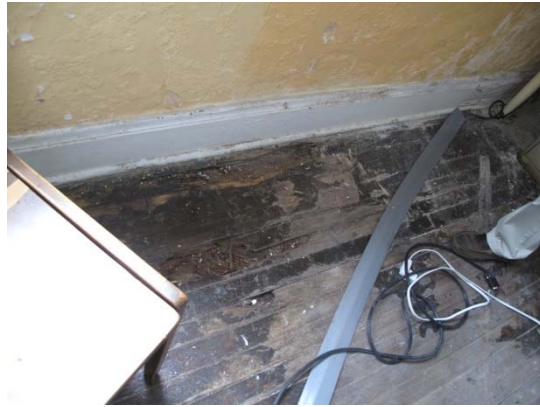
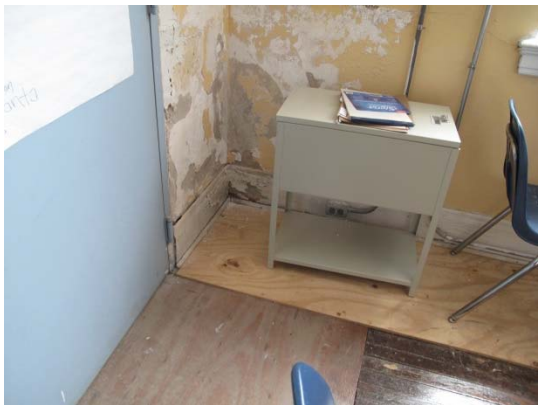
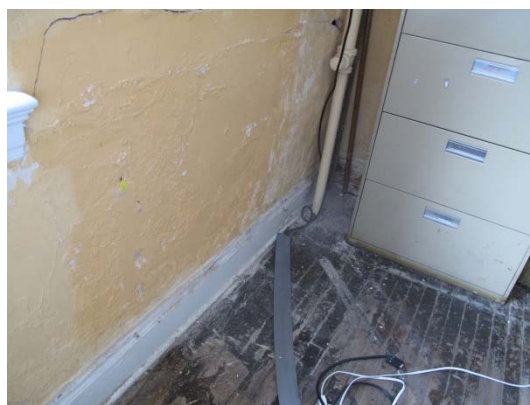
**Floors:**

Terrazzo, concrete, and VCT floors are in good condition. Wood floors have some water and termite damage mostly when adjacent to a balcony or roof, occasionally damage at floor adjacent to a window.

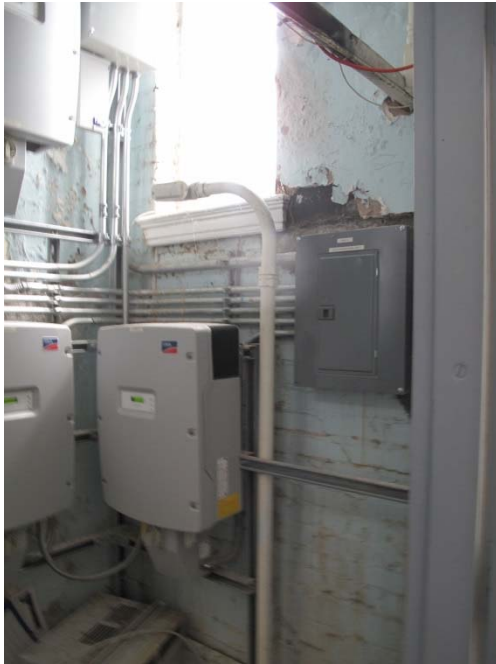
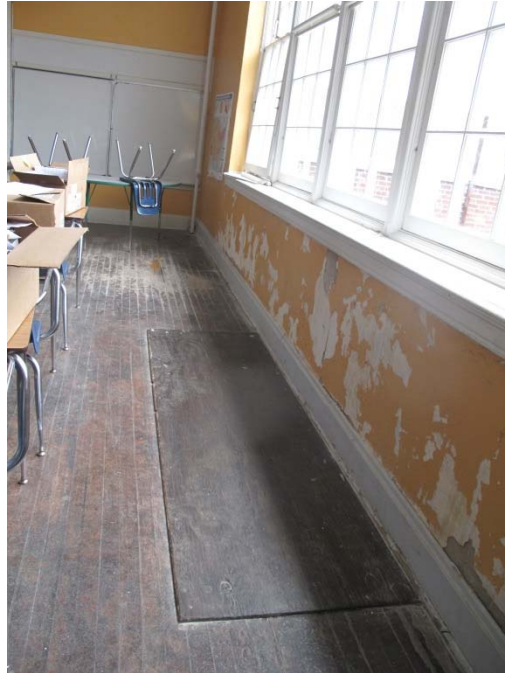
**Walls:**

Water damage visible at exterior walls, some cracking and bubbling of plaster is occurring.

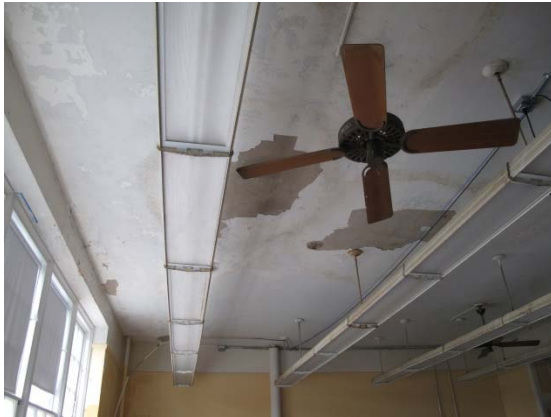
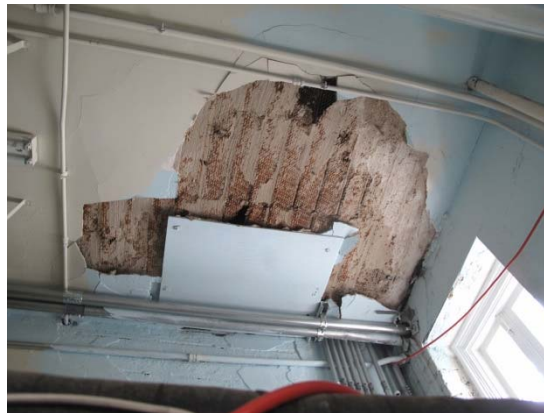
**Ceilings:**

Third floor has multiple locations of water damage causing plaster to come off the ceiling and exposed rusted lath. The auditorium has sagging 2x2 tiles indicating moisture issue as well as some locations of water damage. Roof repairs are needed and repairs to ceilings are needed.

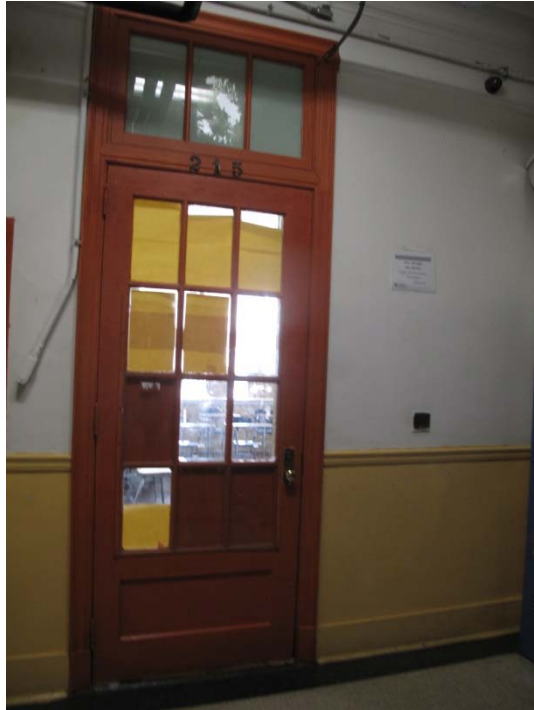
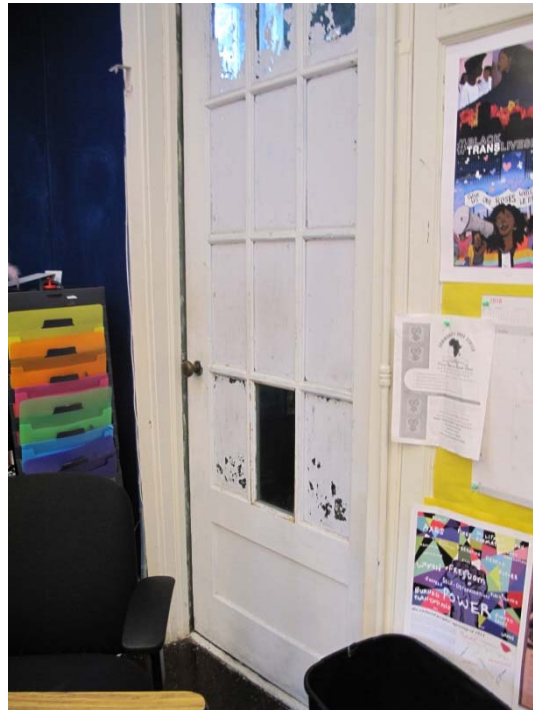
**Doors and Door hardware:**

Wood doors and transoms have painted over glass and occasional wood infill at missing glass locations. Door hardware often requires tight gripping and twisting. Current code does not allow unrated doors and transoms in a unsprinklered building in a corridor wall.

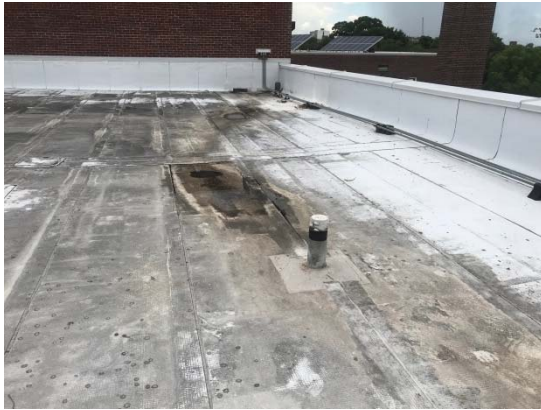
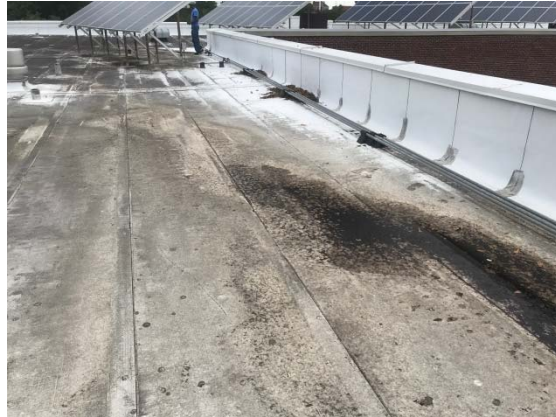
**Roof:**

There are some locations of constant standing water. One significant location of water under the roofing membrane. Damage to ceilings of rooms below indicate roof repair is needed in multiple locations.

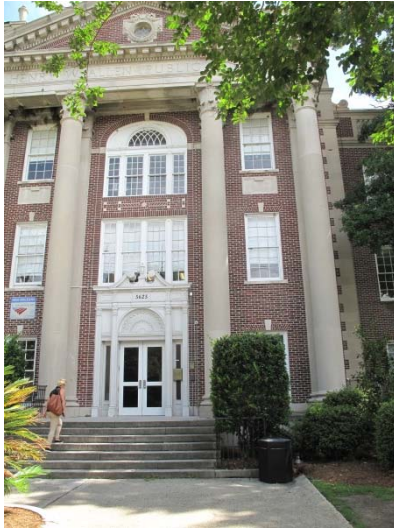
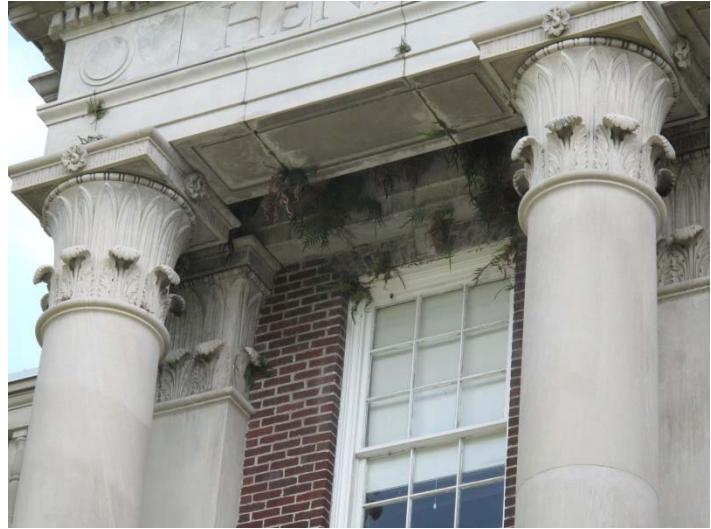
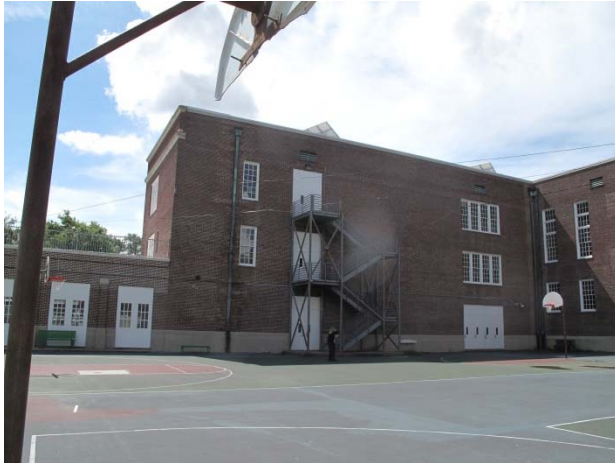
**Exterior:**

Exterior is in good shape. Some vegetation needs removal from front entry and possibly some minor tuckpointing at a few locations where water infiltration is visible at interior plaster. Brick discoloration around one downspout, may indicate a repair needed for the scupper and thru wall flashing.

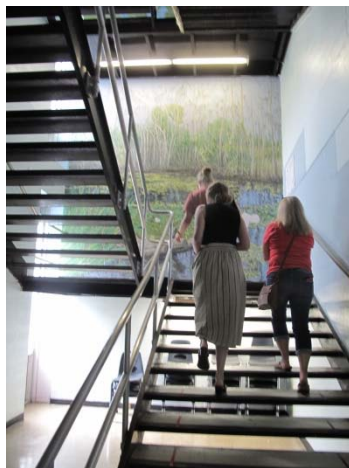
#### Stairs:

Stair guardrails and handrails are not to current code. Guardrails exceed allowable gap sizes. Open riser treads also do not meet current code.

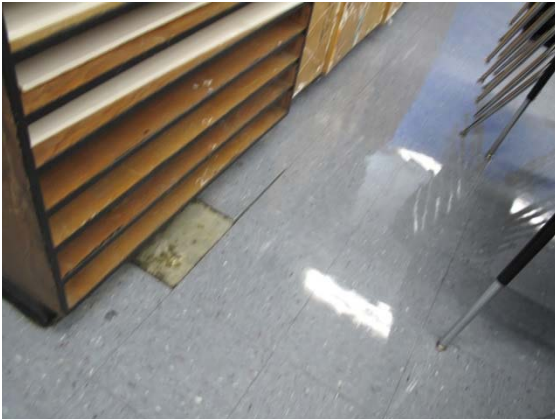
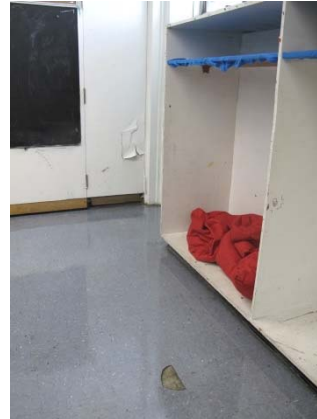
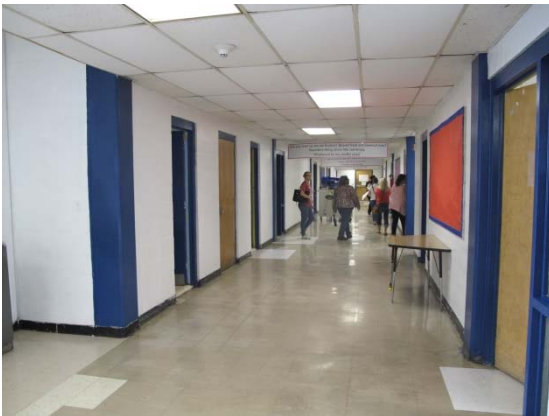
#### Floors:

Floors are in good condition. Only very minor chips in vct at few locations. VCT patches do not match adjacent in color.

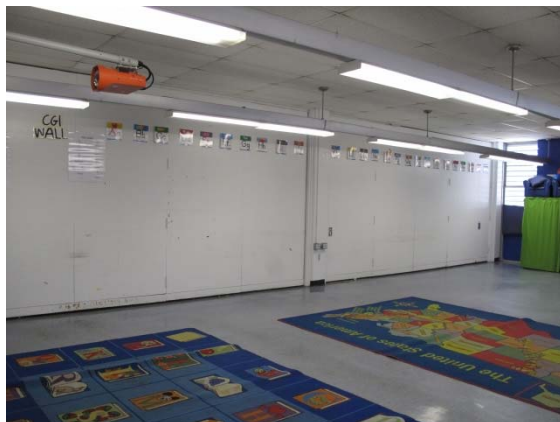
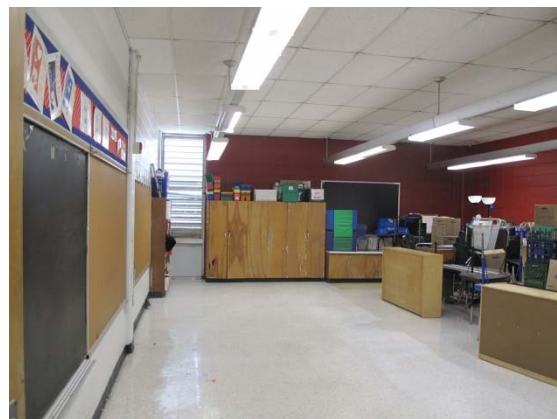
**Walls:**

The majorities of walls are cmu and are in good condition. Operable partitions between classrooms need further evaluation as we have not checked if they are in working operation.

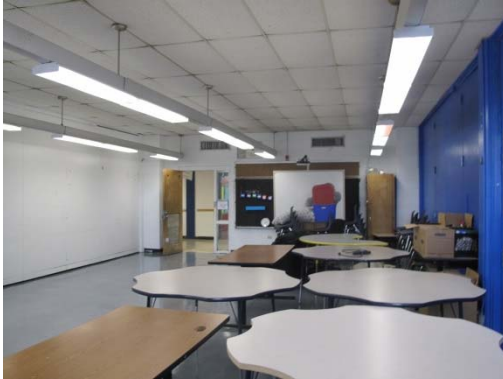
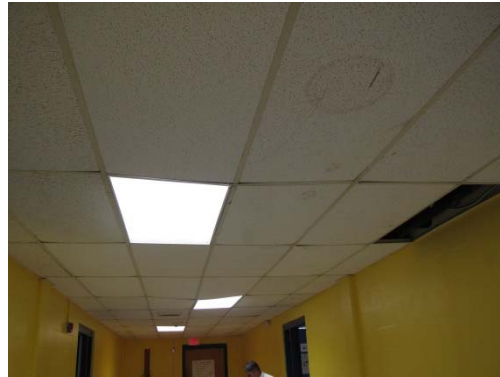
**Ceilings:**

ACT ceiling tiles consistently sag, indicating moisture content in air is consistently too high.

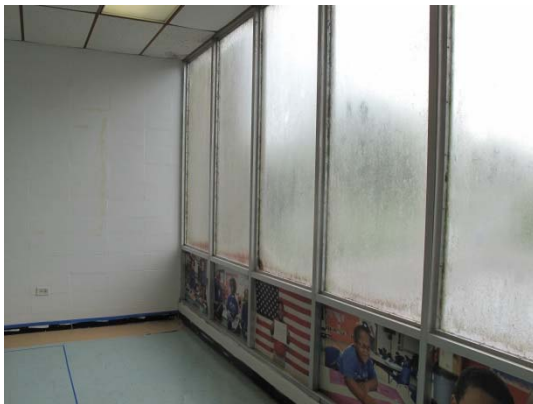
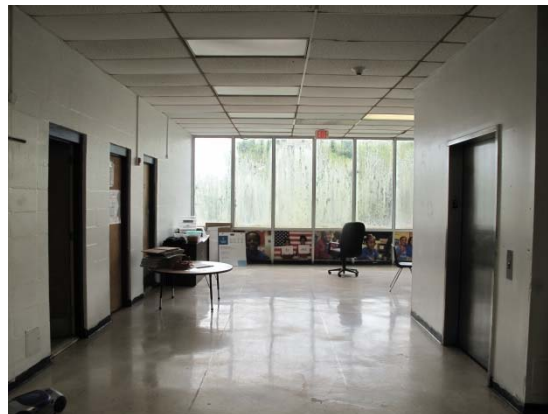
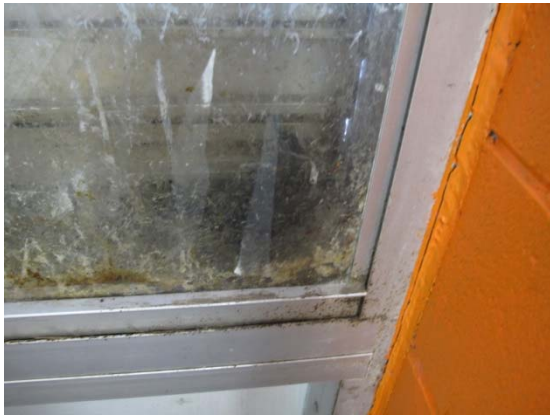
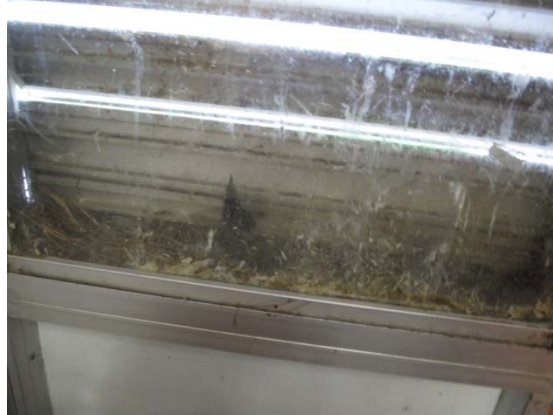
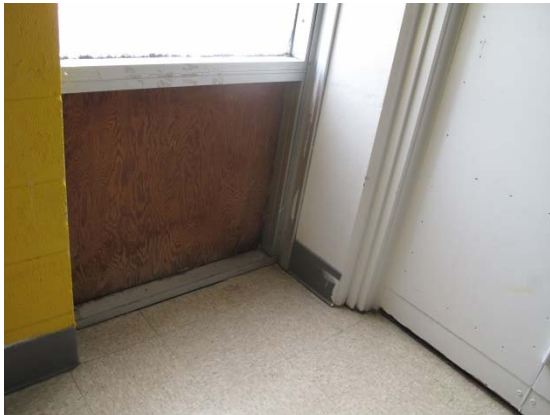
**Windows:**

All windows are in need of cleaning. The windows do not appear to be insulated and there for form lots of condensation. Many windows have birds 'nests with multiple birds living between the louvers and the glass. Some rusting at windows is occurring.

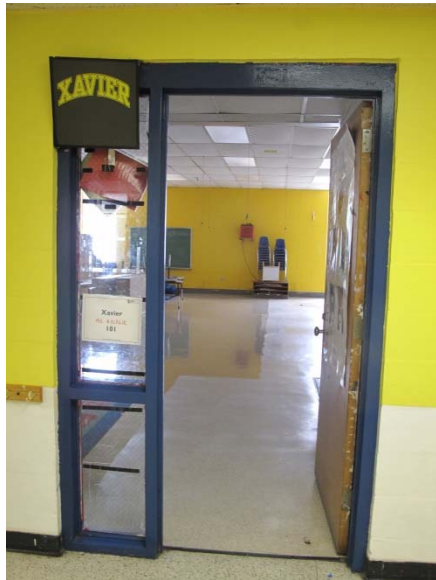
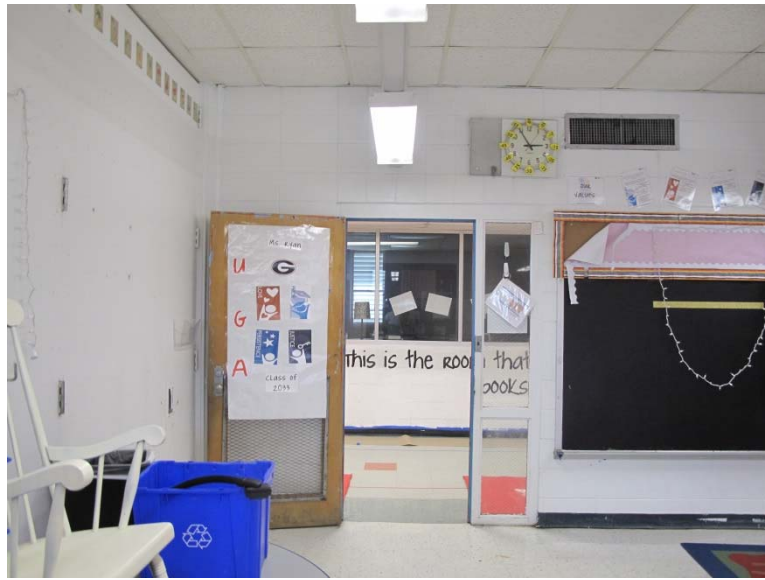
**Doors and Door hardware:**

Current code does not allow unrated doors in an unsprinklered building in a corridor wall. Hardware often requires tight gripping and twisting.

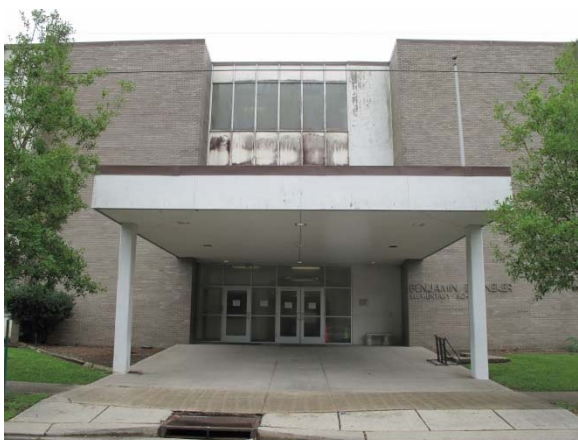
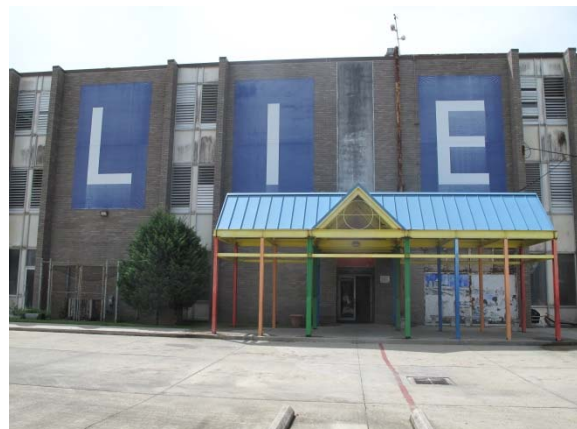
**Exterior:**

Exterior brick is in good shape. The windows and louvers need to be cleaned and frames and spandrel need to be cleaned, prepped, and painted. Some spandrel may need replacing. Many spandrels pieces are greatly discolored, some were infilled with plywood and are deteriorating. Further investigation is needed to determine how many panels may need replacing. Louvers and frame at first floor Mechanical to exterior parking area is heavily rusted and wood infills within frame are deteriorating this should be replaced.
