**Board Informative:  
MSA-1 Demolition Contract  
Interior Demolition Change Order #1**

**Date: October 23, 2017**

RE: **Limited Asbestos and Lead-Based Paint Survey Report**  
Magnolia Science Academy  
18220 and 18224 Sherman Way  
Reseda, California 91335  
CSC Project No. 4007968

**LIMITED ASBESTOS and LEAD-BASED PAINT  
SURVEY REPORT**

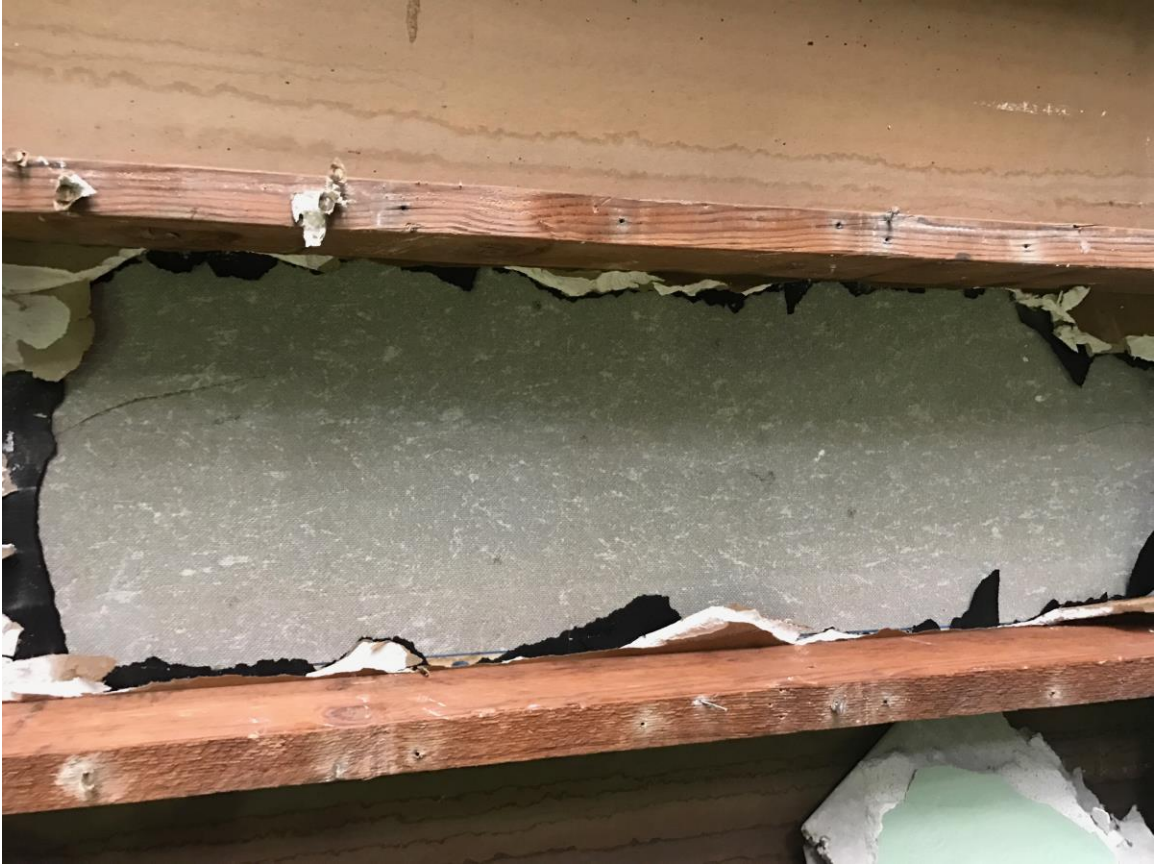
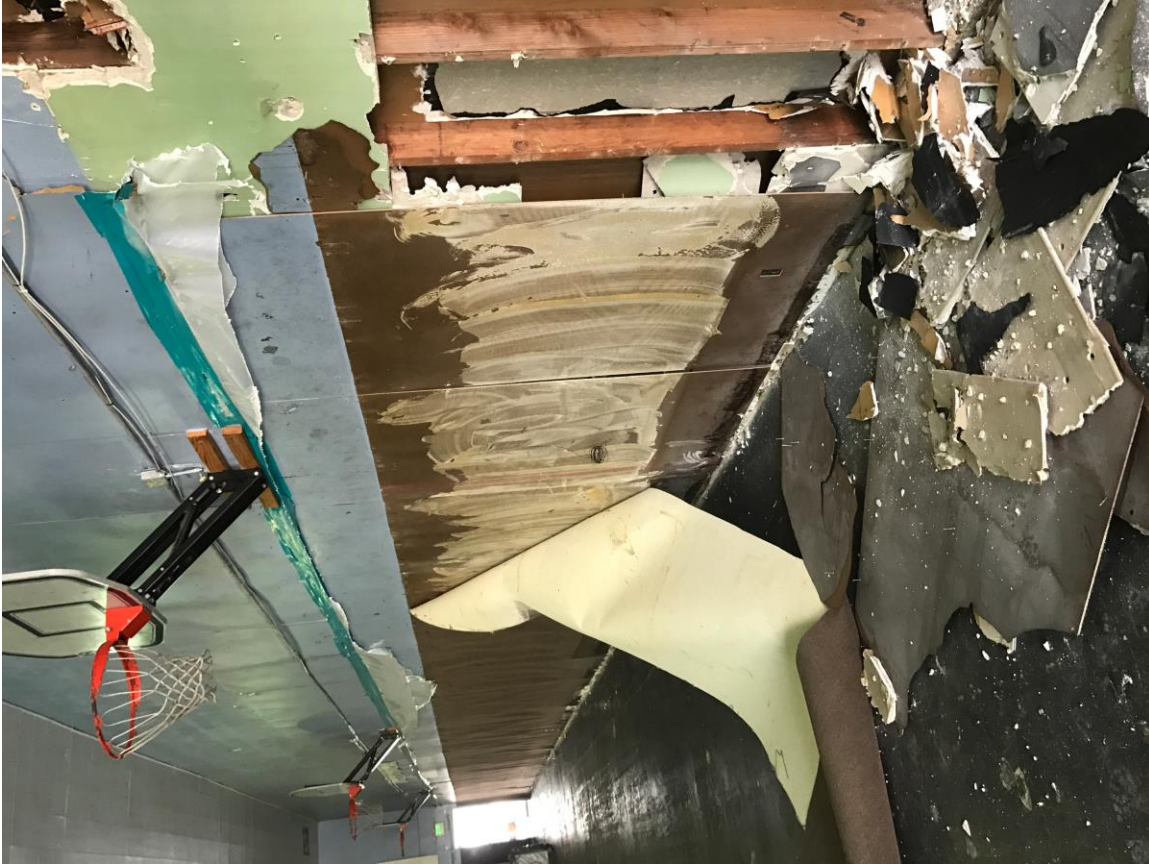
However, after Interior demolition began work it opened a wall built to split the building into two gymnasiums where it discovered the use of Transite paneling. Transite was a commonly used exterior siding material that contains non-friable asbestos; when removed, it must be removed following standard asbestos handling, wrapping, and disposal regulations. CSC confirmed the identity of the panels and their required removal and treatment.

Below are pictures of the opened wall. The Transite is the light gray material covered by drywall. It appears likely that the Transite was used across the entire separation wall, and perhaps elsewhere. Interior Demolition is in the process of opening the other three walls to investigate whether Transite was used elsewhere.

The separation wall contains approximately 4,000 square feet of Transite. PrimeSource negotiated a removal price of \$2.00 per square foot. PrimeSource is requesting a NTX authorization of \$10,000.00 to deal with the separation wall plus a contingency in case Transite is found elsewhere.

Demolition of the building cannot proceed until all asbestos is removed.
