Subject: 979 Behrman Hwy.  
Terrytown, LA

At your request, we conducted an inspection of the subject property on October 5, 2021. We conducted this inspection specifically to determine the condition of the roof after damages were sustained due to Hurricane Ida. To perform this inspection, we utilized a drone with an infrared camera and have included that report as a separate attachment. During this visual inspection, we walked the school building and the roof surfaces with Mr. Norman Bijou, Facilities Manager. During this inspection, we utilized a non-intrusive moisture meter to verify moisture under the roof surfaces and plotted those readings on a report from IMGIMG, a copy of which is attached.

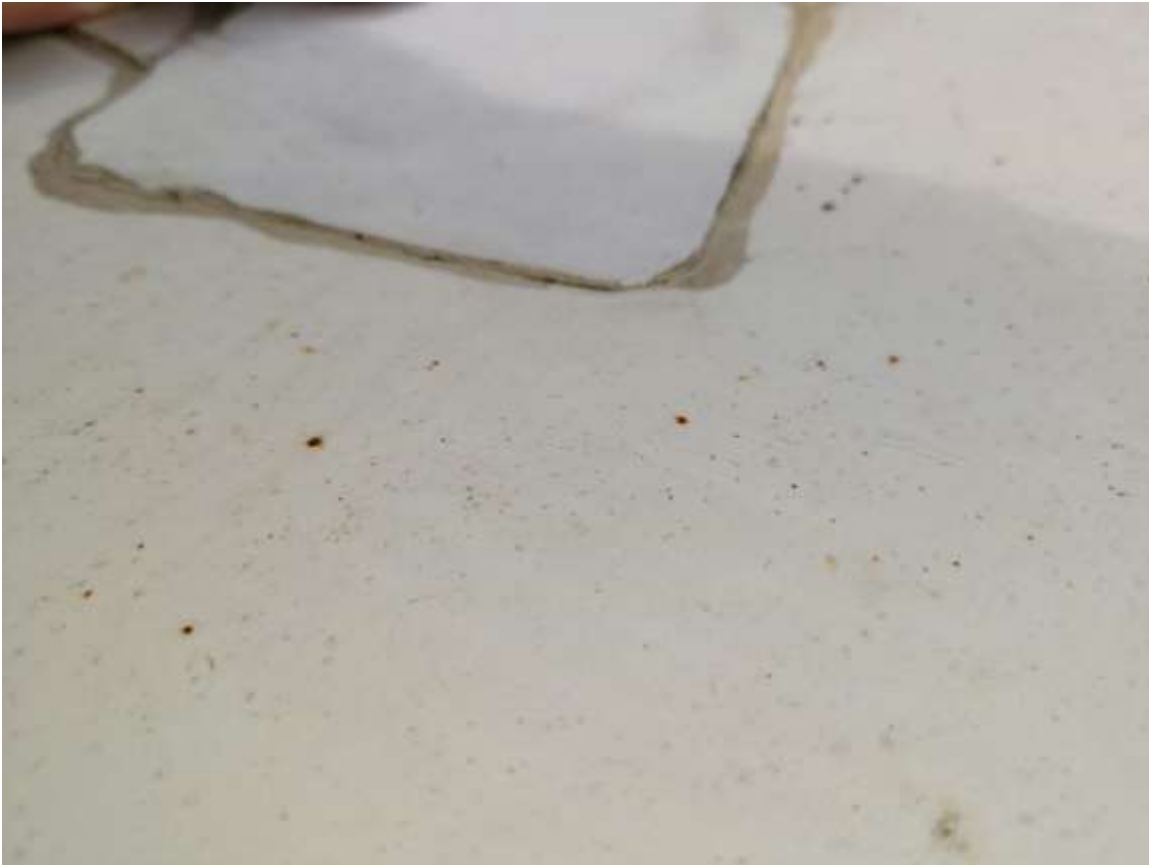
Same.
