BUR Conexion

Construction Challenge:

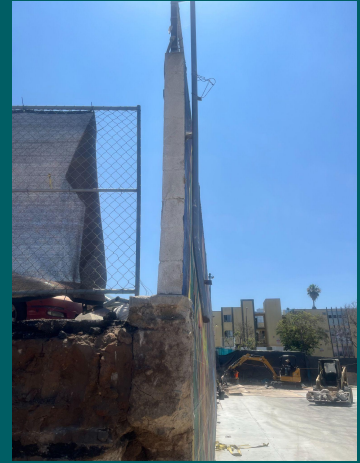
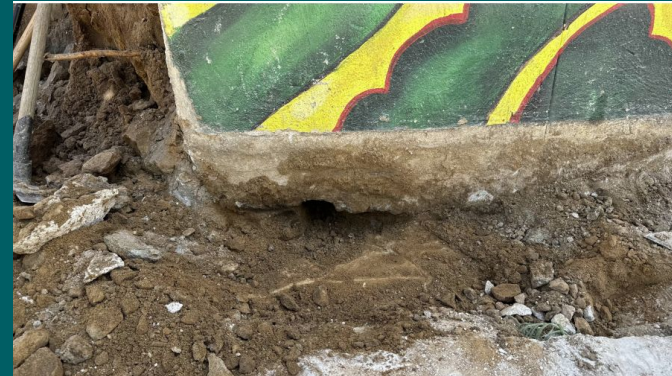
Issues/ Observations: Upon visual inspection of the mural wall (98'X15') attached to the parking structure, Ridgeline Construction believes that the mural wall is not structurally sound. After scanning the walls adjacent to the mural wall, it was discovered that the walls do not have rebar, or any other type of structural support, this leads Ridgeline Construction to believe that the mural wall does not have rebar or any sort of structural support. This is a safety hazard. See images below.

Recommendation: Ridgeline Construction recommends the demolition of the mural wall and having it re-built with proper support per structural engineers' recommendation.
