Agenda Item:	IV B: Action Item
Date:	November 20, 2024
To:	Magnolia Educational & Research Foundation dba Magnolia Public Schools (“ MPS ”) Board of Directors (the “ Board ”)
From:	Alfredo Rubalcava, CEO & Superintendent
Staff Lead(s):	Patrick Ontiveros, Director of Facilities & General Counsel Mustafa Sahin, Project Manager Katrina Jimenez, Assistant Project Manager
RE:	Approval of Purchase of 18120 Sherman Way and Execution of Purchase and Sale Agreement between HH Sherman, LLC, as Owner and Seller, and Magnolia Educational & Research Foundation for the Benefit of Magnolia Science Academy-7, as Purchaser

PHASE I ENVIRONMENTAL SITE ASSESSMENT
Proposed Public School Facility
18120-18118 Sherman Way
Reseda, CA 91335
APN 2125-036-083

MAGNOLIA SCIENCE ACADEMY 7
TEST FITS

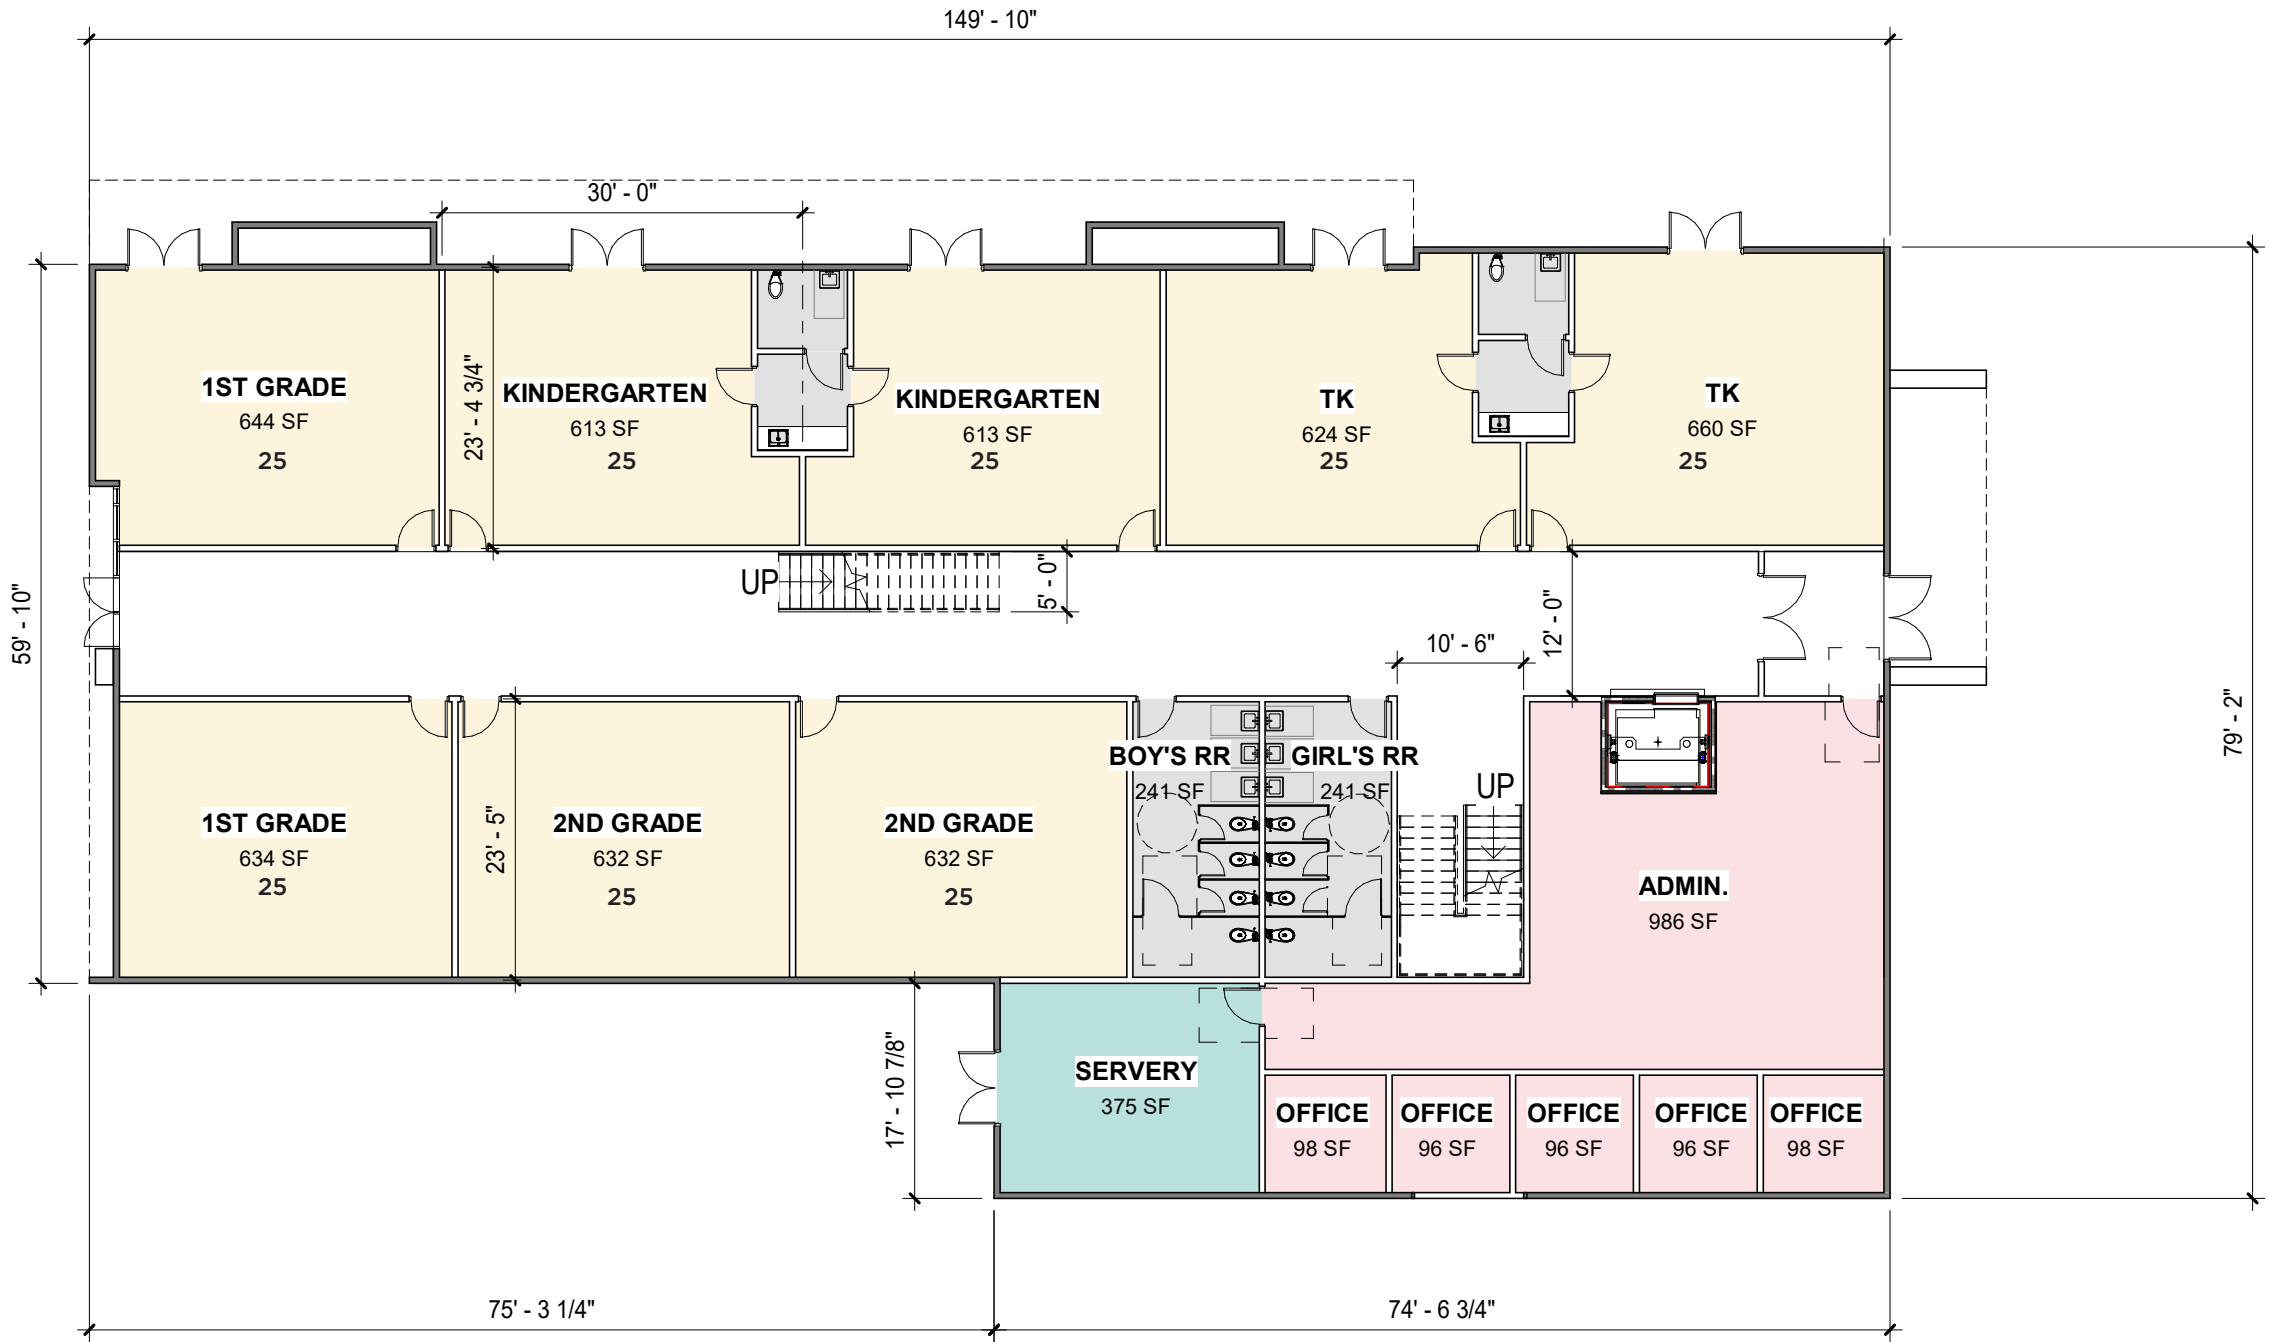
PHASE 1

14 CLASSROOMS
 1ST FLOOR = 8 CLASSROOMS
 2ND FLOOR = 6 CLASSROOMS

362 STUDENTS
 1ST FLOOR = 200 STUDENTS
 2ND FLOOR = 162 STUDENTS

--- LINE OF EXISTING FLOOR

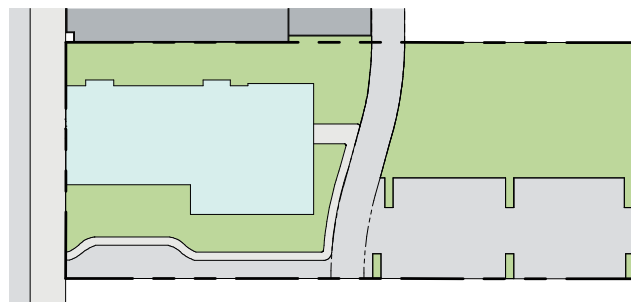
PHASE 1

14 CLASSROOMS
362 STUDENTS
16,744 SF

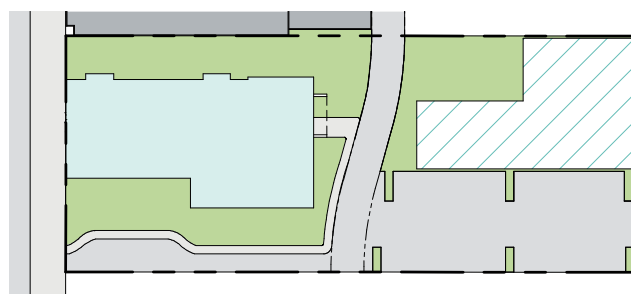
PHASE 1 + PHASE 2

23 CLASSROOMS (21 + 2 SPECIALTY)
551 STUDENTS
26,051 SF

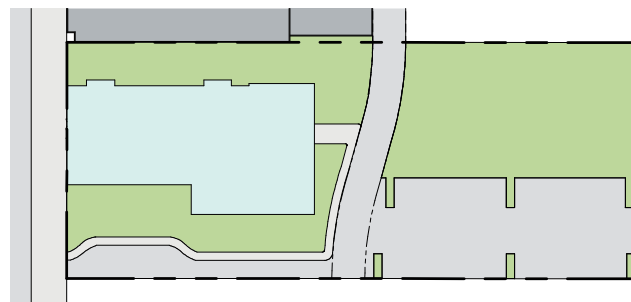
PHASE 1

18 CLASSROOMS
470 STUDENTS
20,094 SF

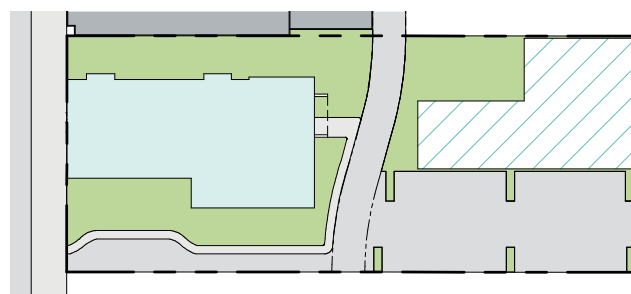
PHASE 1 + PHASE 2

22 CLASSROOMS (21 + 1 SPECIALTY)
578 STUDENTS
25,950 SF

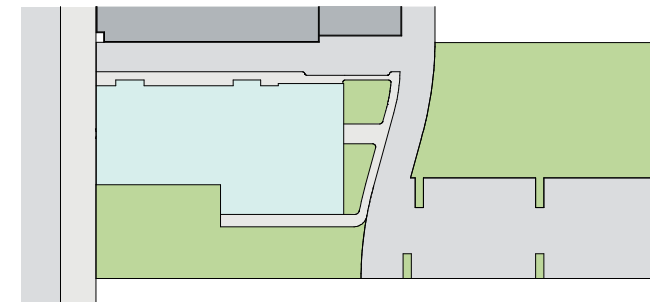
PHASE 1

18 CLASSROOMS
470 STUDENTS
20,094 SF

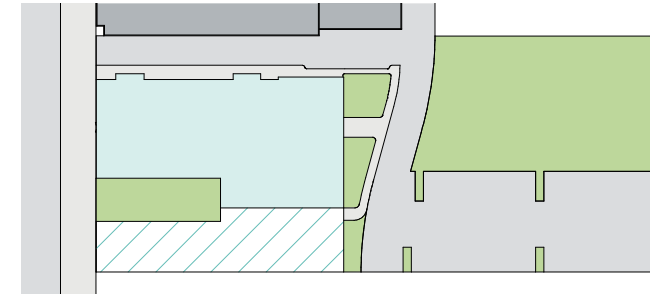
PHASE 1 + PHASE 2

21 CLASSROOMS
551 STUDENTS
24,474 SF
