F.A.M.E., Inc.

## Facility Committee Meeting

**Audubon Charter School**  
**Program and Building Assessments**  
*New Upper Elementary & Middle School Campus*

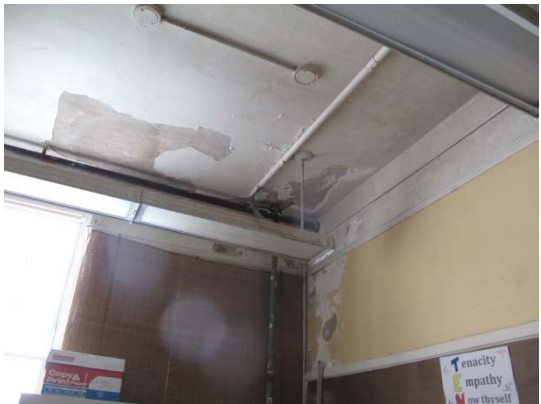
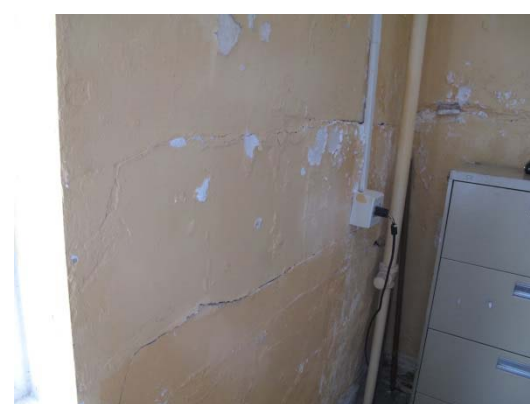
Water damage visible at exterior walls, some cracking and bubbling of plaster is occurring.

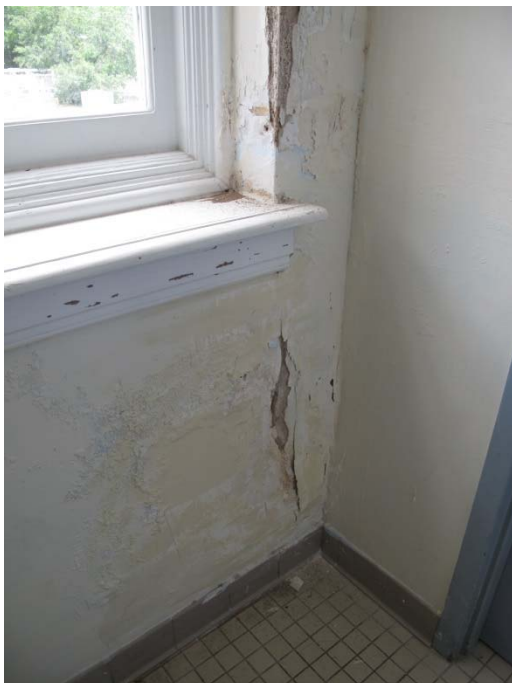
Windows are in decent shape. It looks as though windows were renovated in 2014. One window had visible termite damage to wood trim.
