Magnolia Public Schools

Special Board Meeting

Approval to Award the Construction Contract for Magnolia Science Academy-1

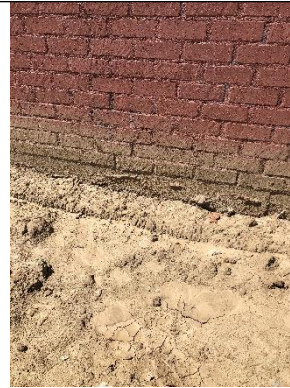
Foundation

Foundations are assumed to be shallow reinforced concrete spread and continuous footings.
